Title: Critical vulnerabilities in devices using code from Treck Software

Advisory ID: CARESTREAM-2020-03

Issue Date: June 16, 2020

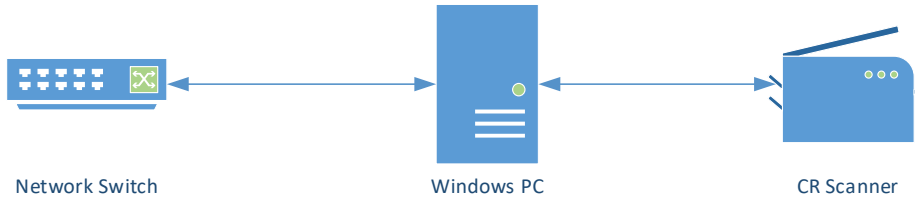
CR scanner devices are used to acquire and send CR images to a Windows PC. Typically, these CR scanners are typically directly connected to a Windows PC that has 2 network adapters – one connected to the CR scanner and one connected to the customer network. The CR scanner itself is not connected to the rest of the network which greatly reduces the attack surface of the system and the risk of any potential vulnerabilities discovered in the future.

If your CR scanner devices are connected to your network, then it is highly recommended that they be modified to operate in direct connect mode. To determine if your CR scanner is connected to your network, see the instructions below.

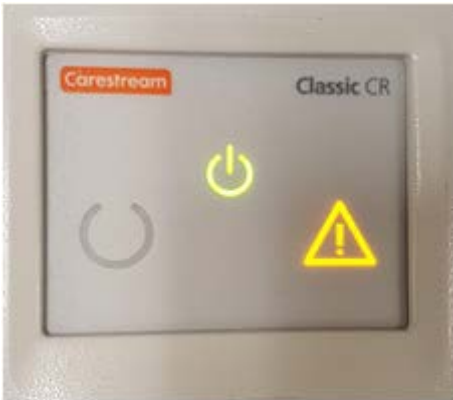
If the display on the Carestream Classic CR or Elite CR looks like the picture below then the device must already have the compensating control of the direct connect mode configuration and no further action required.

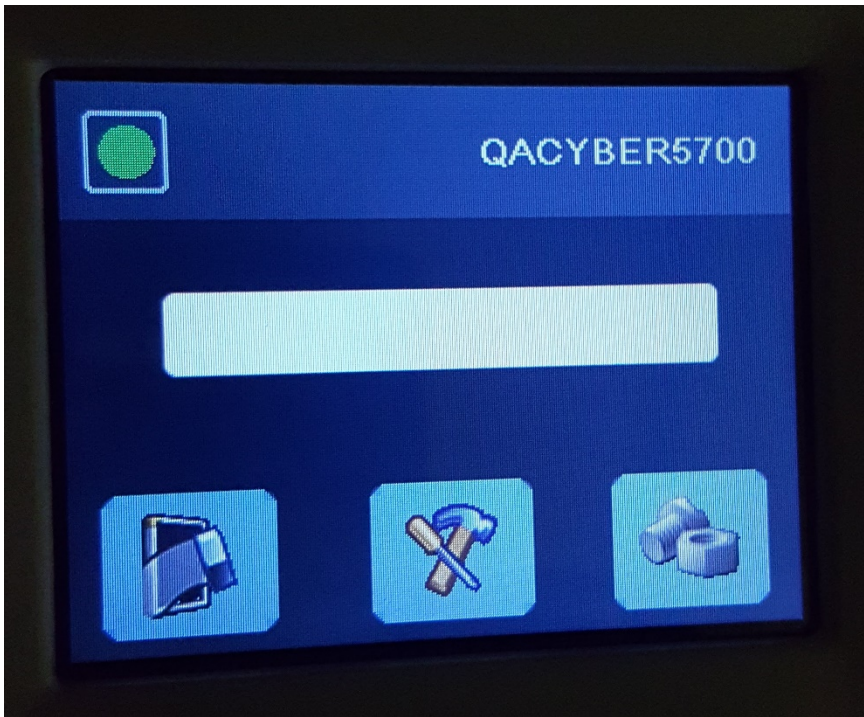
If the display on the Carestream Classic CR or Elite CR looks like the picture below then the device *may not* have the compensating control of the direct connect mode configuration. Further identification is required in the following steps:

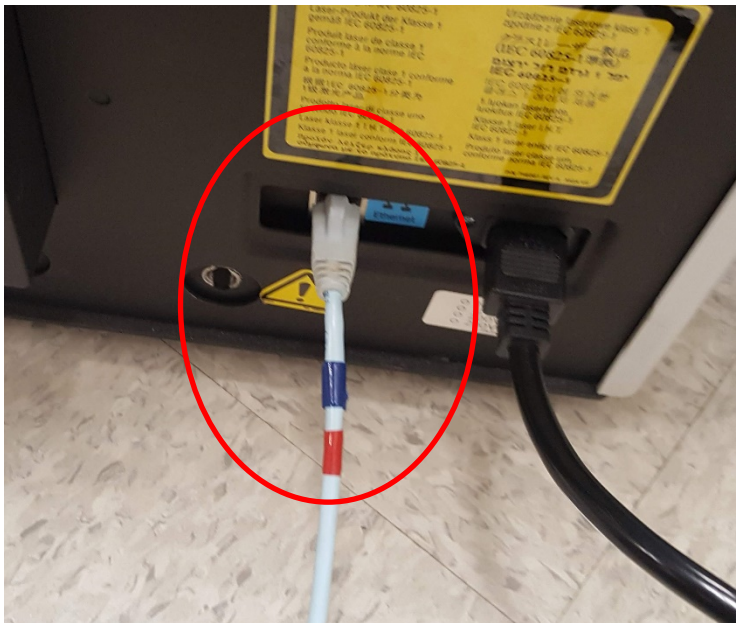
It is possible the CR scanner is connected to your network. Check the back of the equipment for a standard network cable as seen in the picture below:

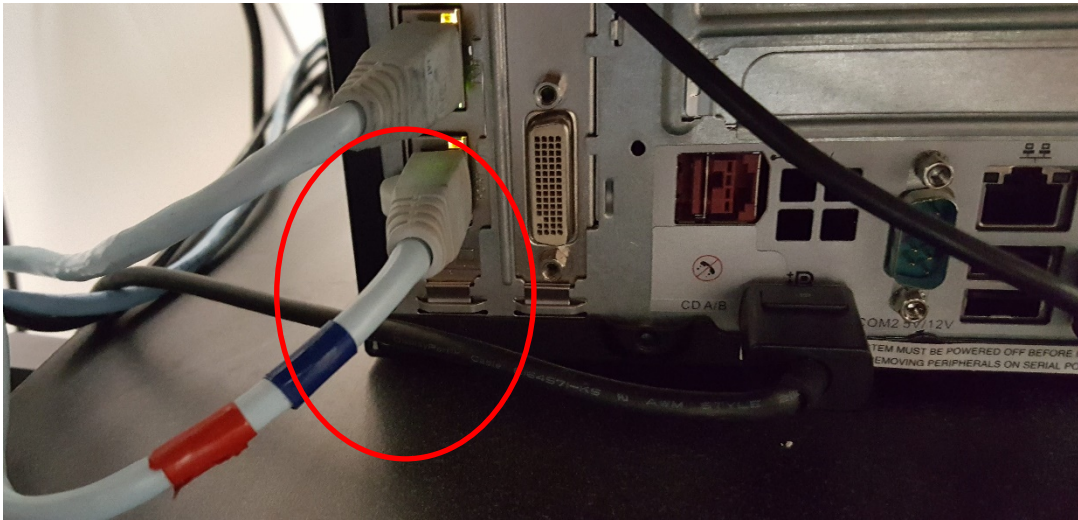
Follow the cable to confirm it is connected to the back of a PC as shown below, not to a network port on the wall or other network device:

If the standard network cable is present and connects the device to a PC then the compensating control of the direct connect mode configuration is in place and no further action is required at this time.

If the standard network cable DOES NOT connect the device to a PC then the compensating control of the direct connect mode configuration is NOT in place. Please contact Carestream Service to receive assistance in making the desired modification of direct connecting the CR scanner to the Windows PC.
