Title: Critical vulnerabilities in devices using code from Treck Software

Advisory ID: CARESTREAM-2020-03

Issue Date: June 16, 2020

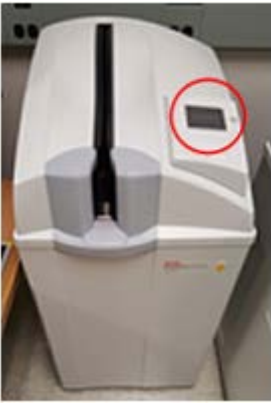
Older Carestream Classic CR and Elite CR systems may not be direct connected by default and may benefit from this modification. Please see the picture below to assist with identification (notice the display is circled for emphasis as this will be used in the next step):

If your CR scanner devices are connected to your network, then it is highly recommended that they be modified to operate in direct connect mode. To determine if your CR scanner is connected to your network, see the instructions below.
